Critical Lift Failure

Rachel K. Banks
Ed Rearick Forum
February 18, 2009

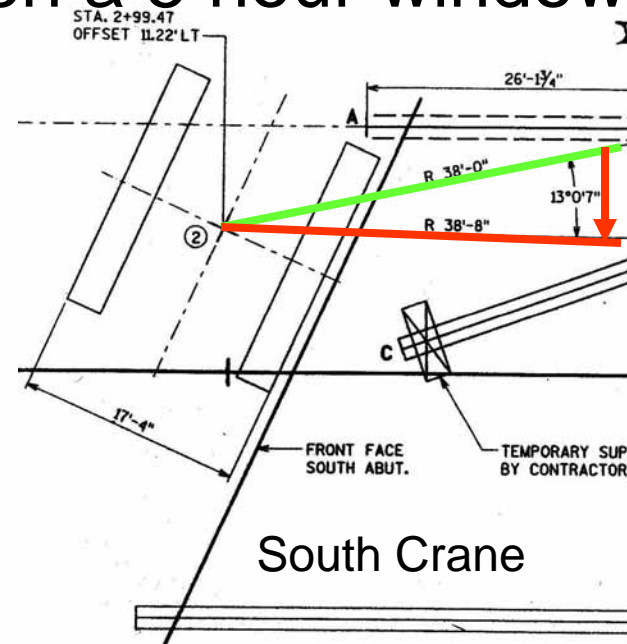
- The company was given a 5 hour window by the railroad.
- North crane
 - 48' boom
 - Working radius 33'-6"
 - Remains in position
- South crane
 - 88' boom
 - Working radius 38'-0"
 - Would rotate a little more than 13 degrees

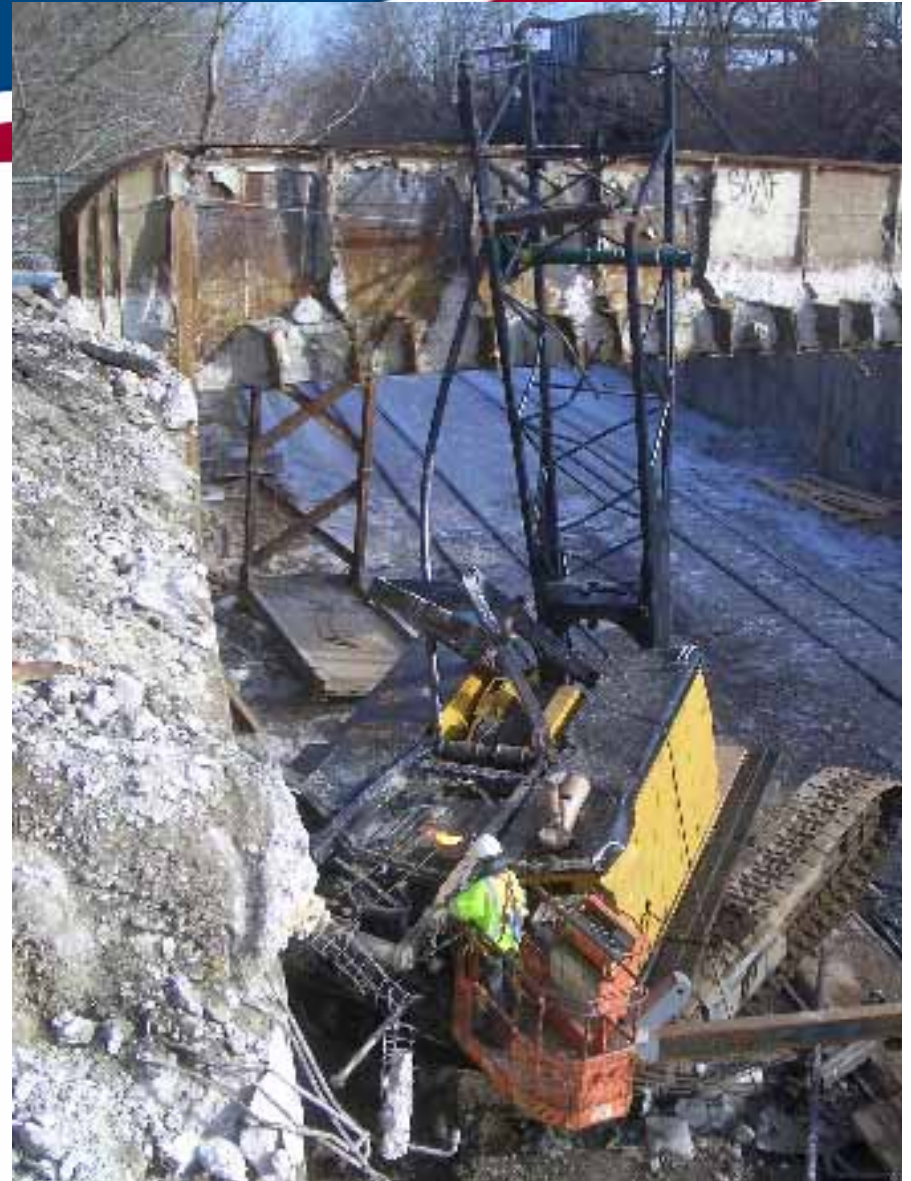
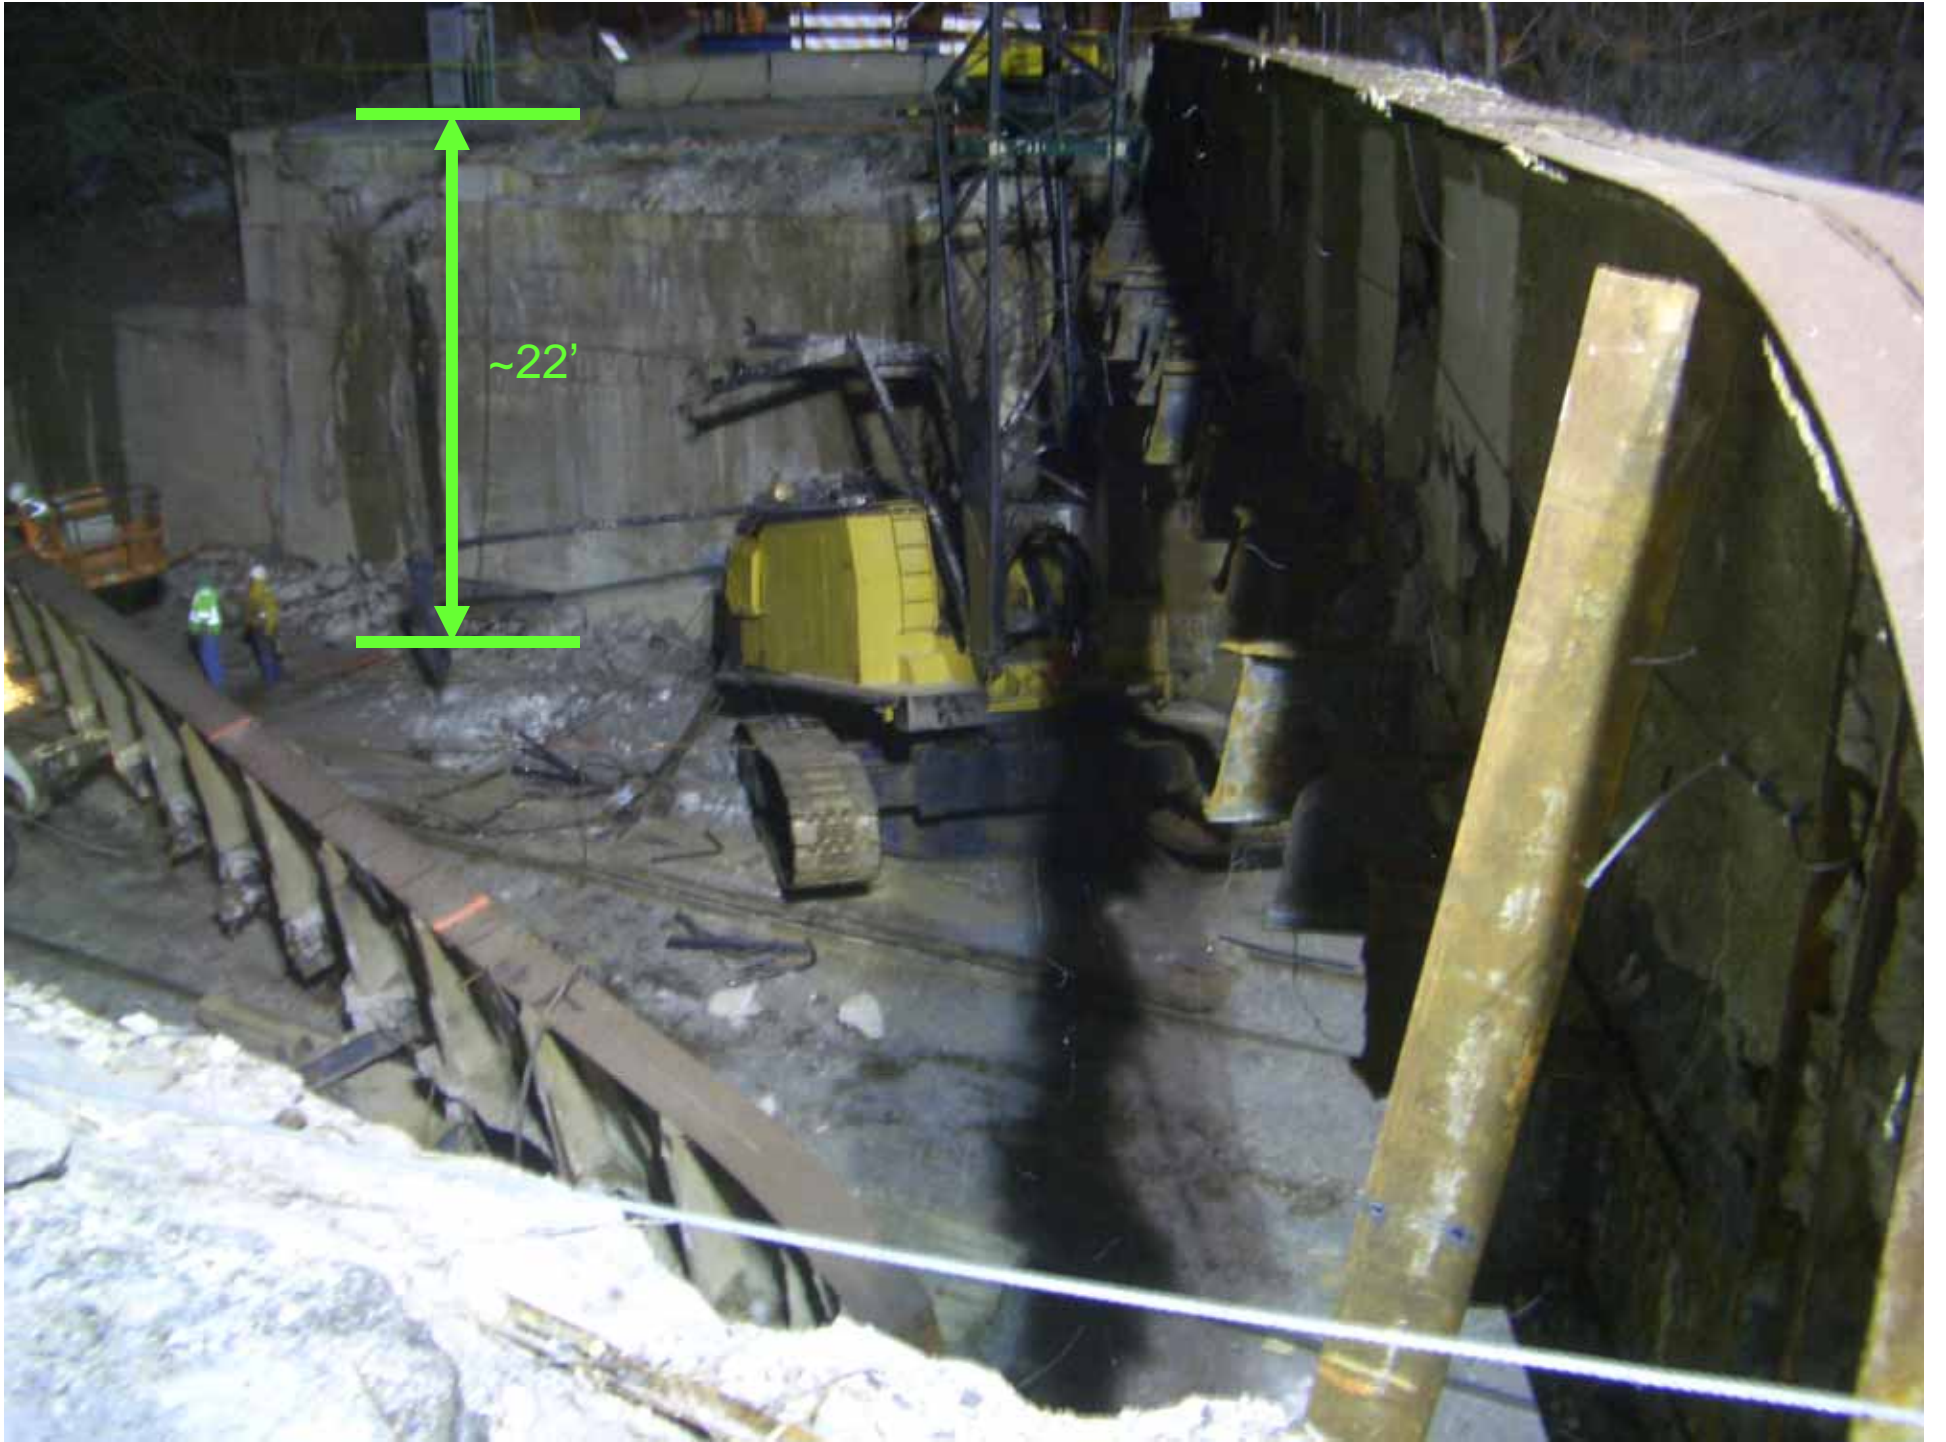
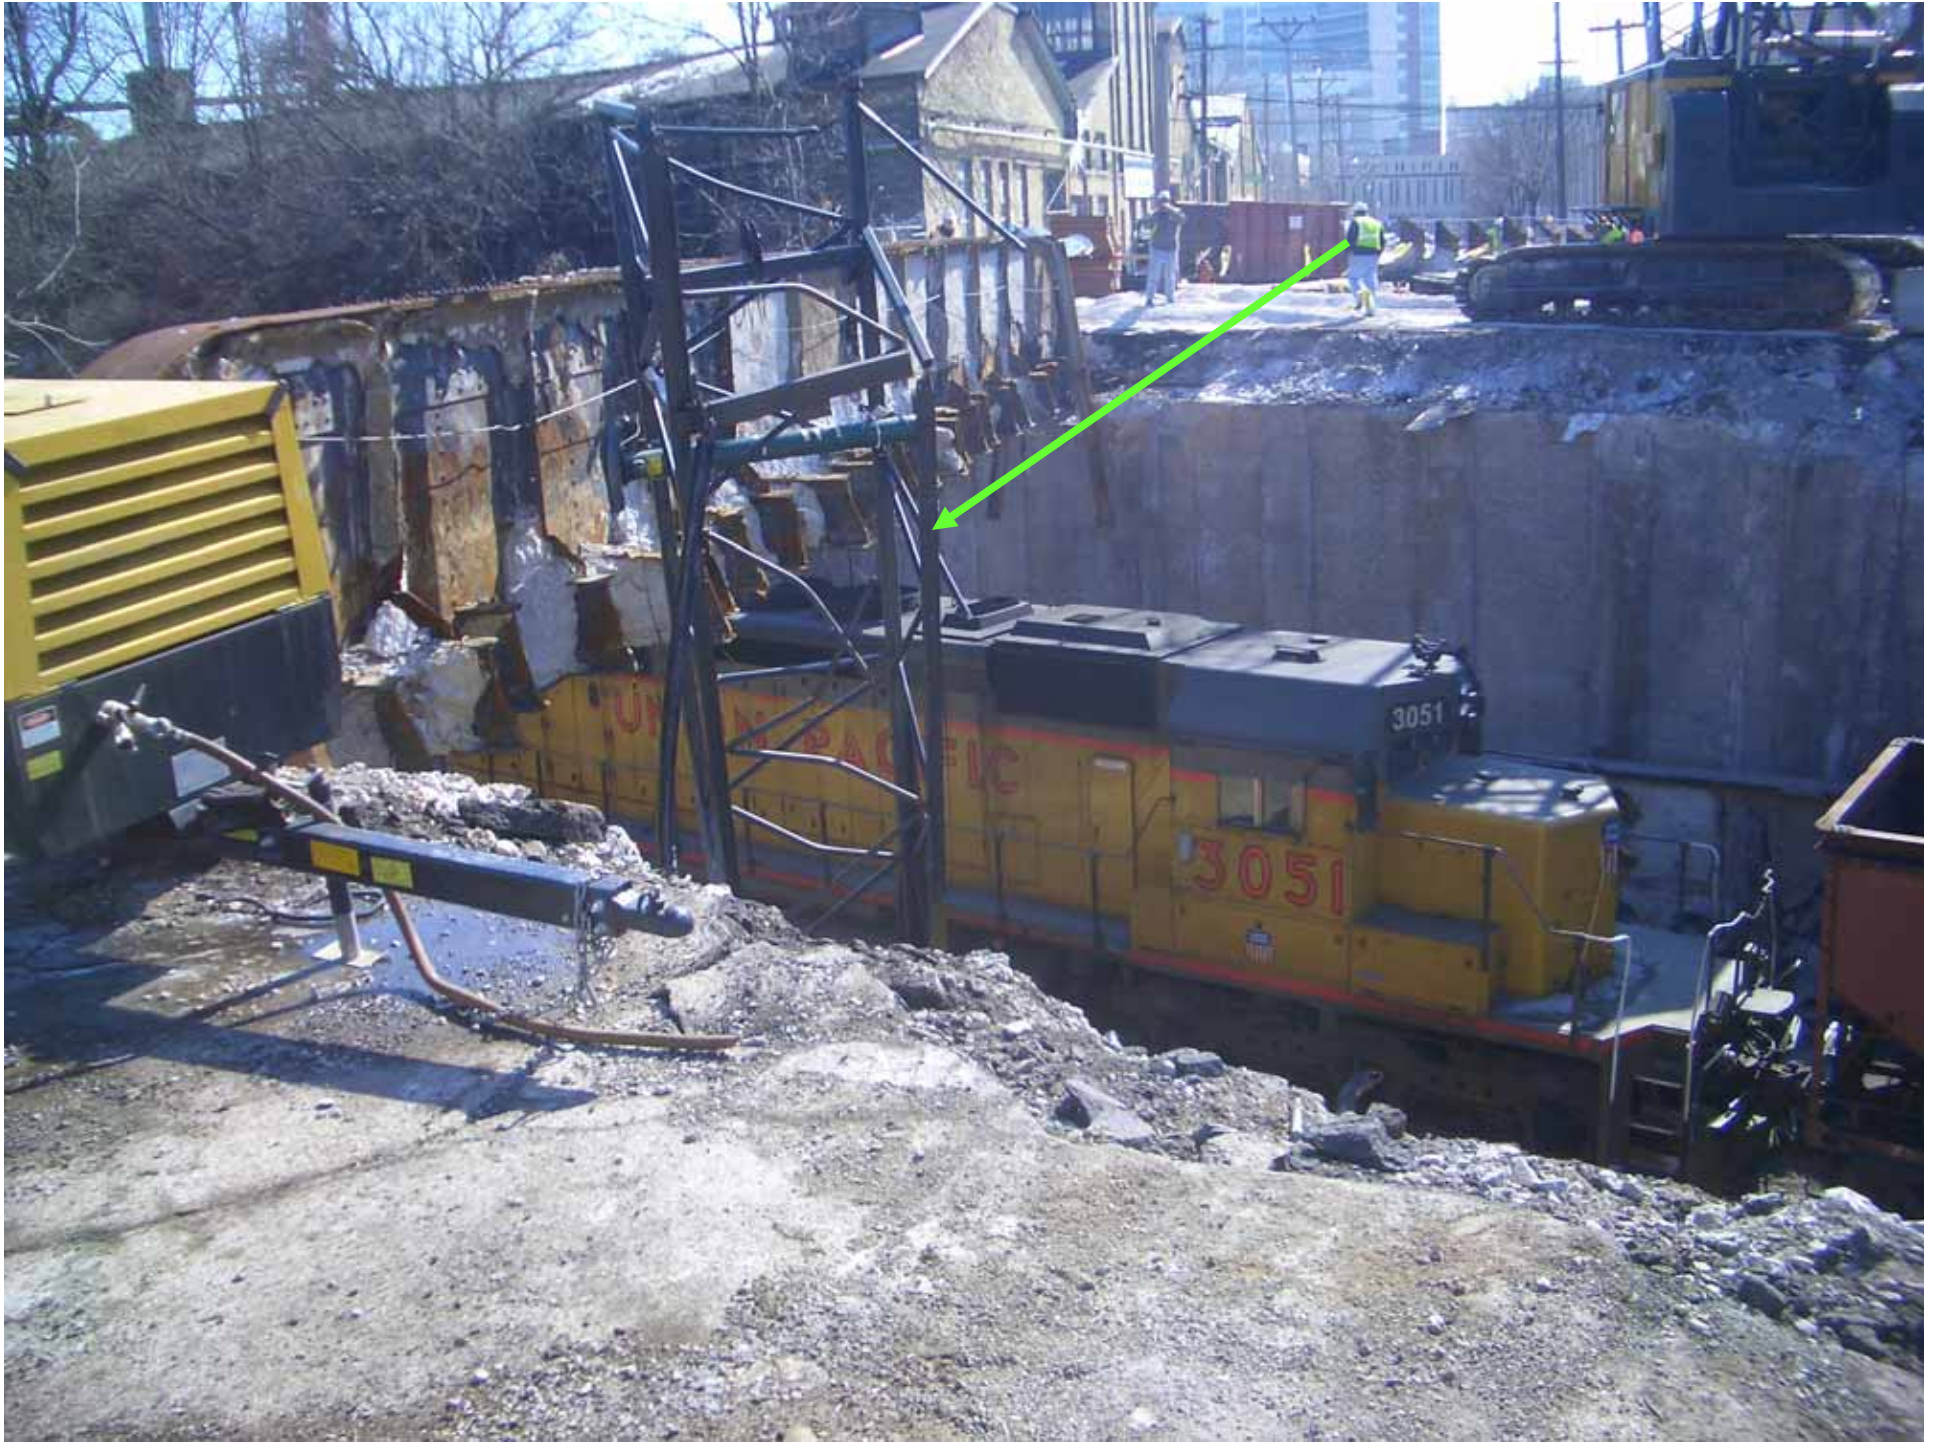
- South crane's rear lifted
 - Load dropped
- North crane's rear lifted
 - Employee jumped
 - Crane fell approximately 22-23' onto the railroad tracks.

- Dynamic loading due to non-synchronized movements of the cranes.
- Potential movement of the abutment.
- Potential variance in original construction from plans.

- Contractor's rigging
- Weight of the girder
- Cranes Movement
- Crane boom lengths and radii's
- Lack of communication
- Plans were not followed

- Create a completed Critical Lift Plan for both cranes.
- Ensure a Competent Person is on-site.
- Ensure the Crane Operators know the Critical Lift Plan.
- Ensure the Critical Lift Plan is followed.
- Have more direct communication between the two crane operators.
