Critical Lift Failure

Rachel K. Banks
Ed Rearick Forum
February 18, 2009

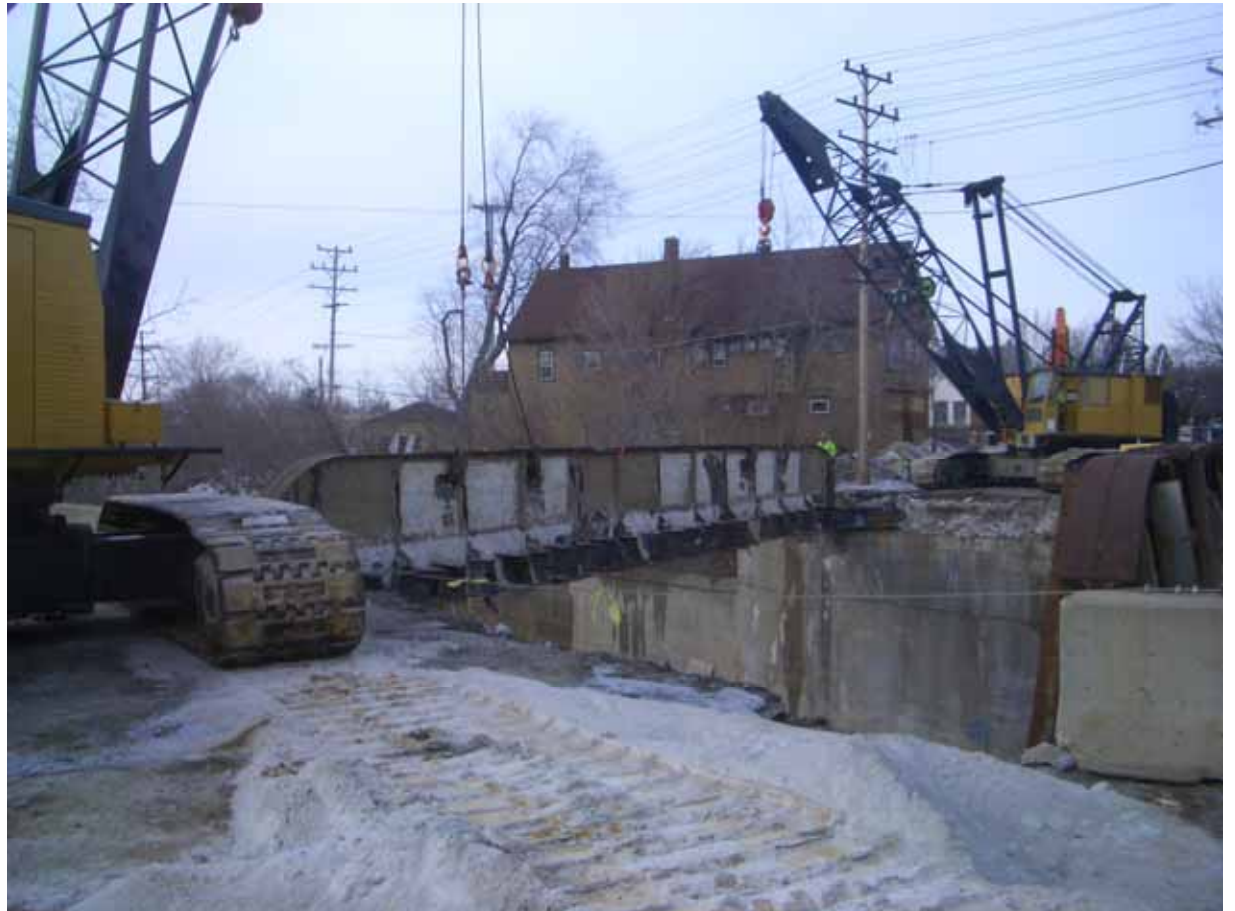
- 1923 Traffic Bridge
- To be demolished and replaced.
- Below the bridge was two sets of active railroad tracks.

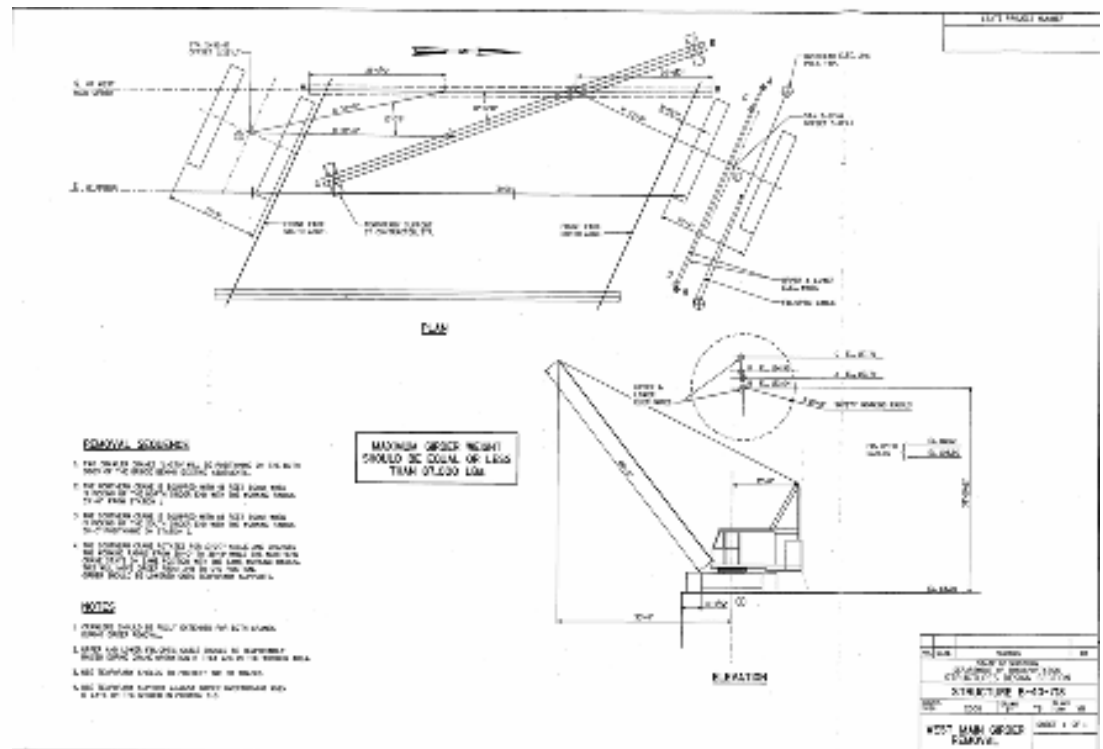
- Several drawings and calculations were performed to determine:
 - What cranes were needed or could be used,
 - Location of the cranes,
 - Rigging, and
 - Angles the boom should be placed at.

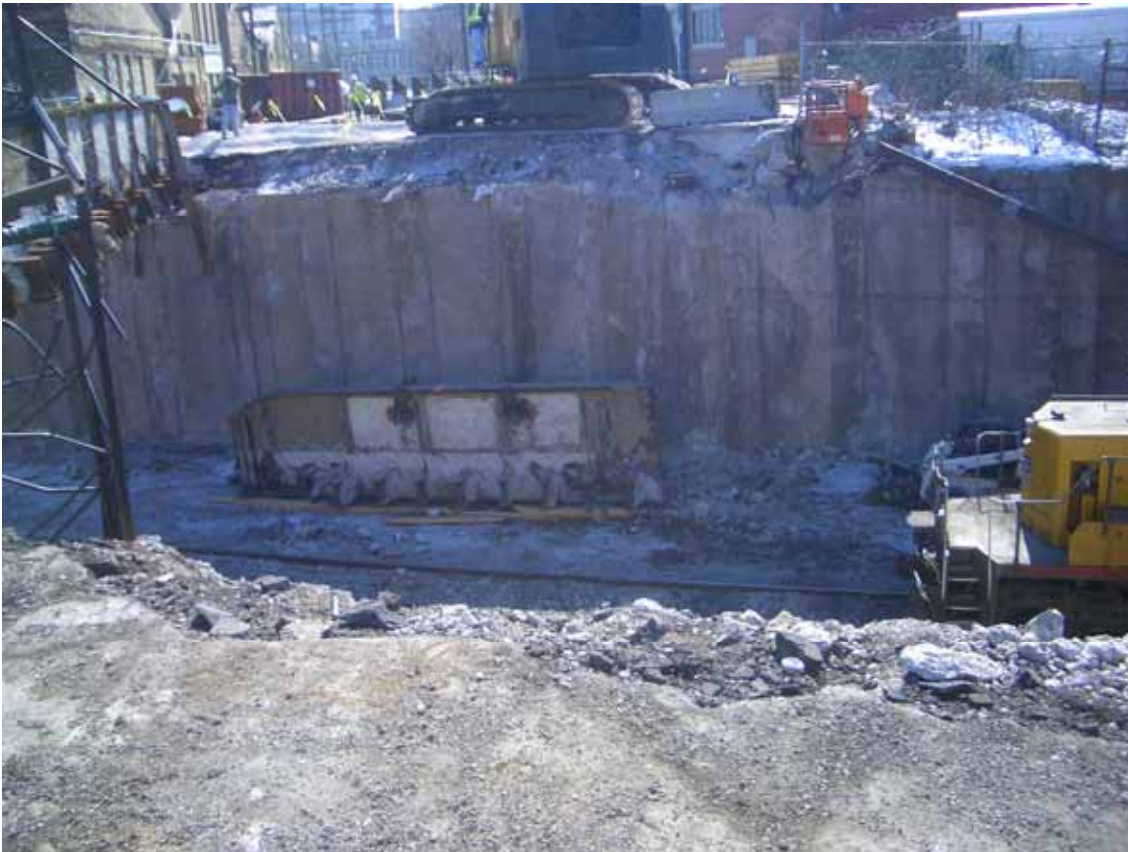
- Dynamic loading due to non-synchronized movements of the cranes.
- Potential movement of the abutment.
- Potential variance in original construction from plans.
